Arch 43

L.S. PAYNE

Waitaki Hydro Works.

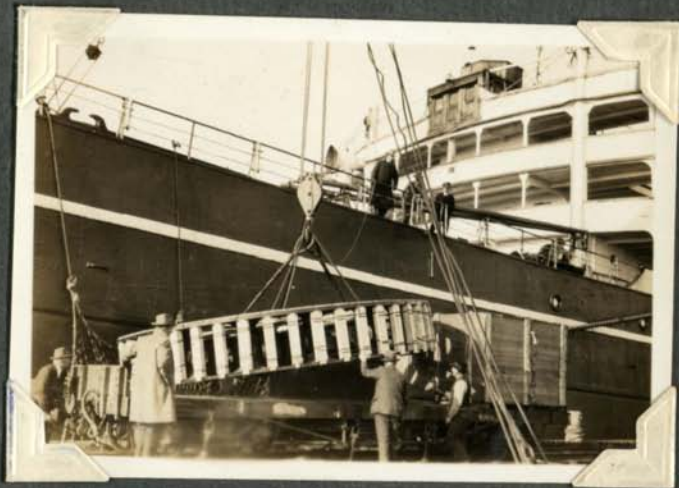
(30)

N^o 2. Generator
half rotor spider.

Dia. 20 Ft.
Weight. 10 Tons.

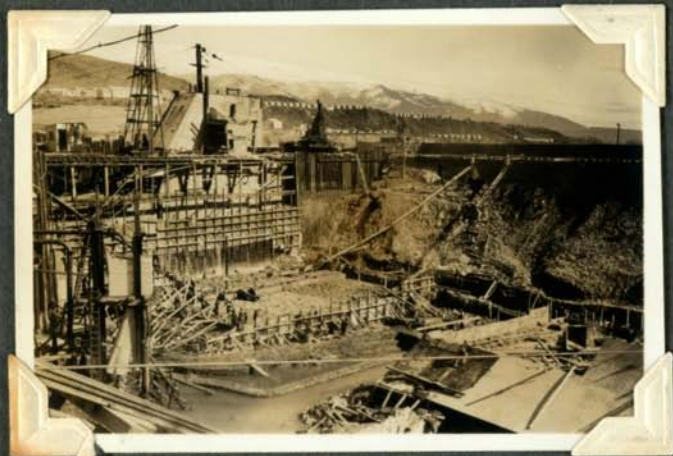
(35)

Midstream side of cofferdam
Water approx. 40ft below
river level outside. Leakage
confined + directed by
sand bags.

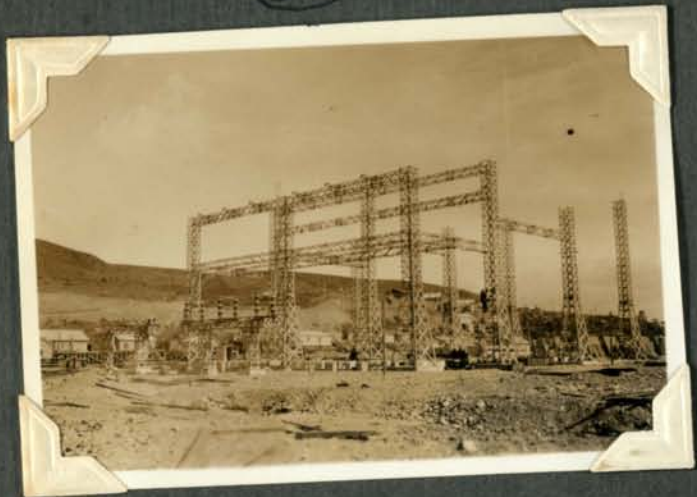
(39)

Lightning arrester, isolating
switches for N^o 1 Line
erected in foreground.
Insulator racks in left
background.

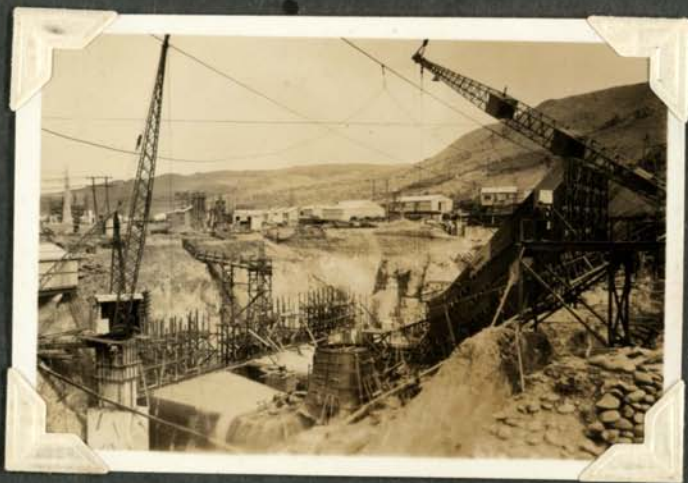
(41)

Powerhouse Foundations.

N°2. steel draft tube in position
ready for top flange ring.

5 Ton Butters crane & 10 ton
Insley crane jib working.

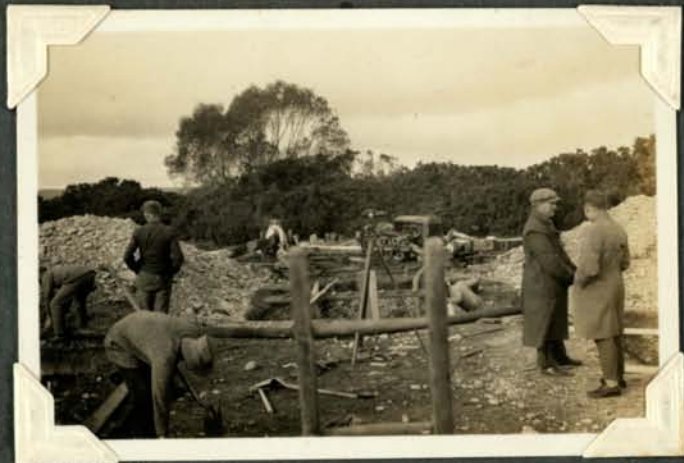
(44)

Third pump being fitted.

Anderson engine with 4"
centrifugal "Tan-gyro" pump.

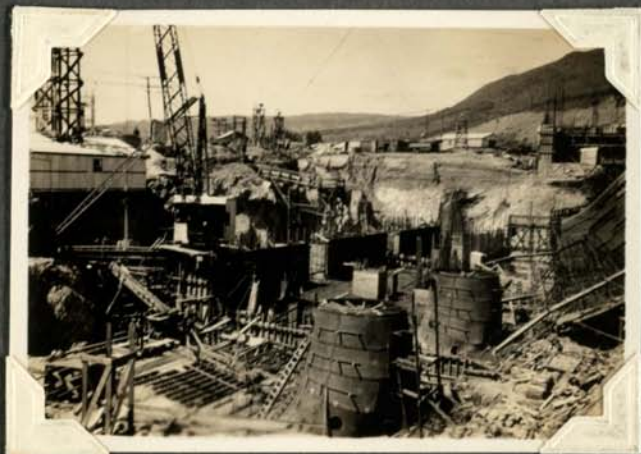
(53)

Nos 1 & 2 Draft tubes being
grouted in position.

View looking downstream.

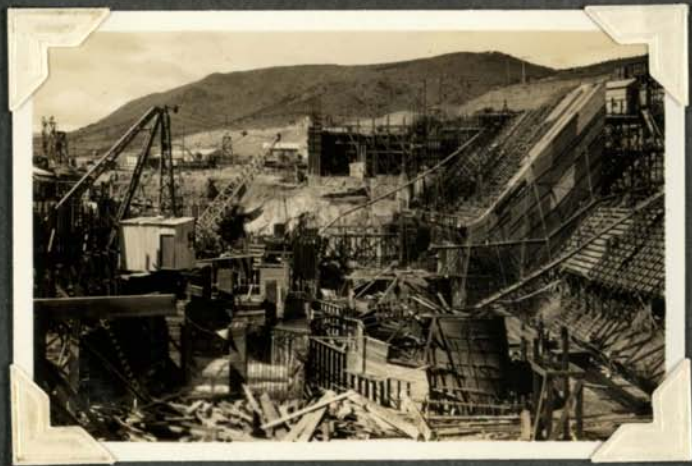
(61)

Workshop and unloading
bay in background.

N^{os} 1 & 2 Turbine draft tubes
in position.

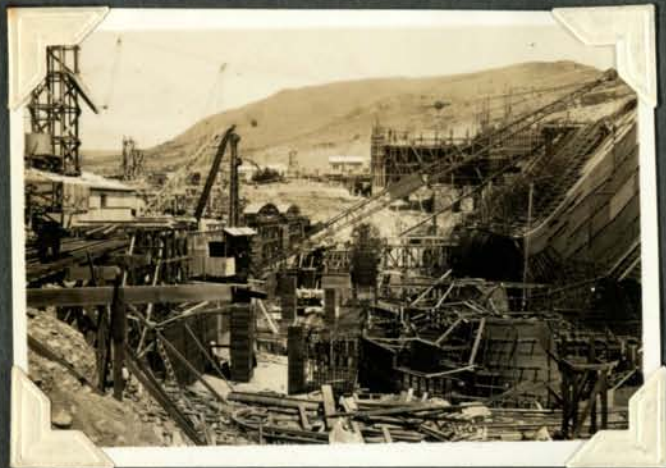
(67)

Main building columns
and arches over tailrace
being boxed.

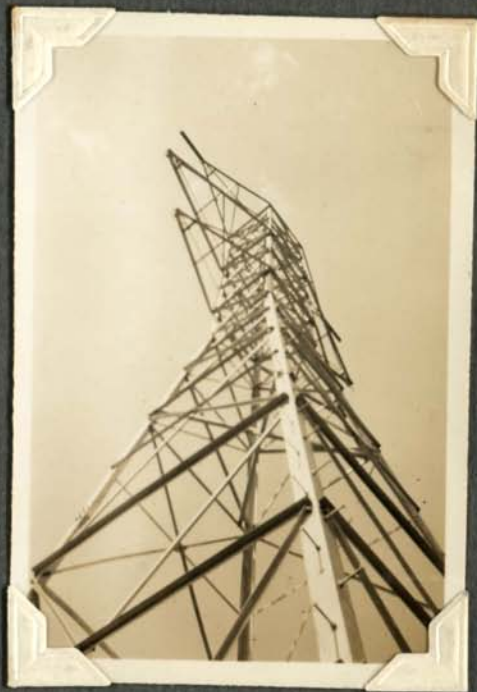
(70)

Tower N^o 120.

To carry double circuit
3 phase. 110 KV. line
37/102 A.C.S.R.

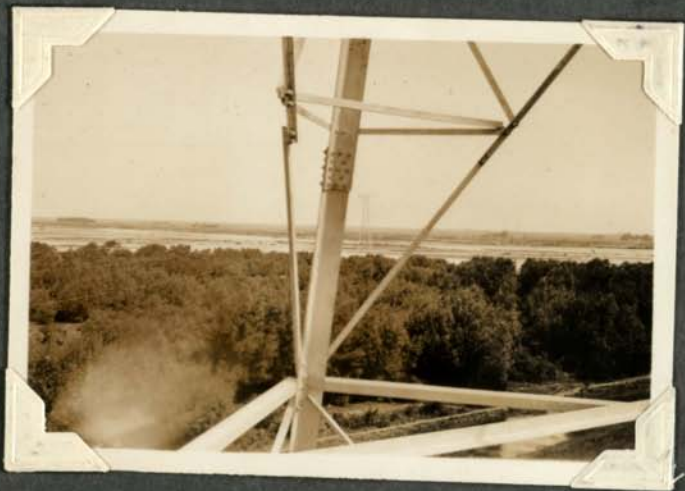
(73)

River crossing will be made
in 2 main spans of 38 chains
+ 34 chains on 130 ft. steel
Towers. Conductor 7/8 Copperweld.
9/16" dia. 12 tons of cable in crossing.

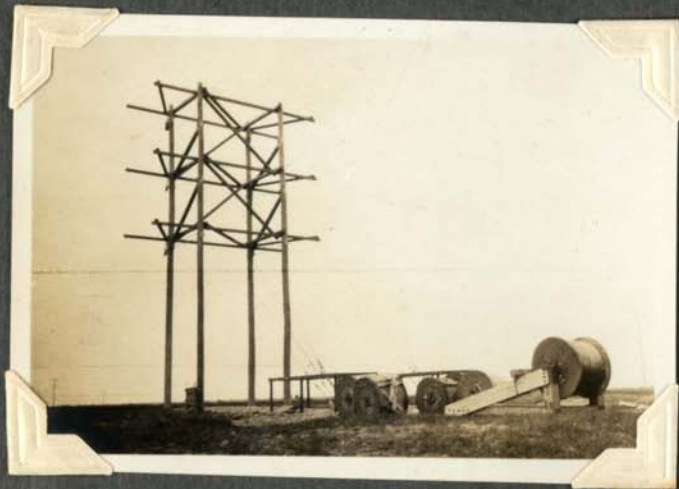
(76)

1/2" dia. steel rope terminated at structure and
spanning river (1 1/4 miles) on temporary interme-
supports in river bed.

Main cable on site ready for stringing.

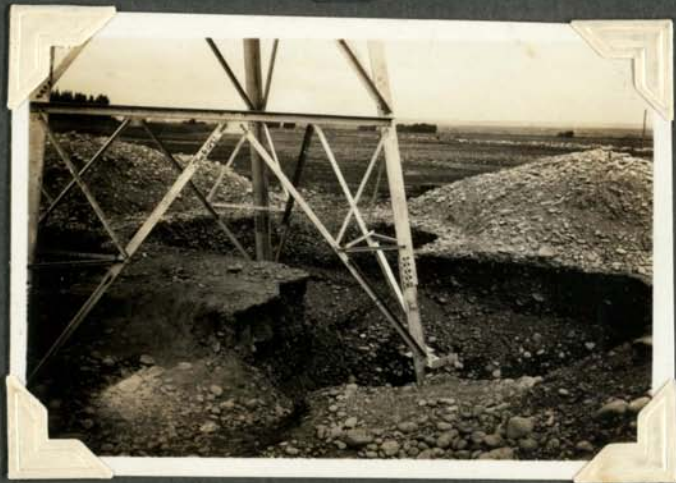
(77)

Strain Tower N^o 74.

Typical running shingle
footing requiring boxing.

Depth of holes - 13'-4"

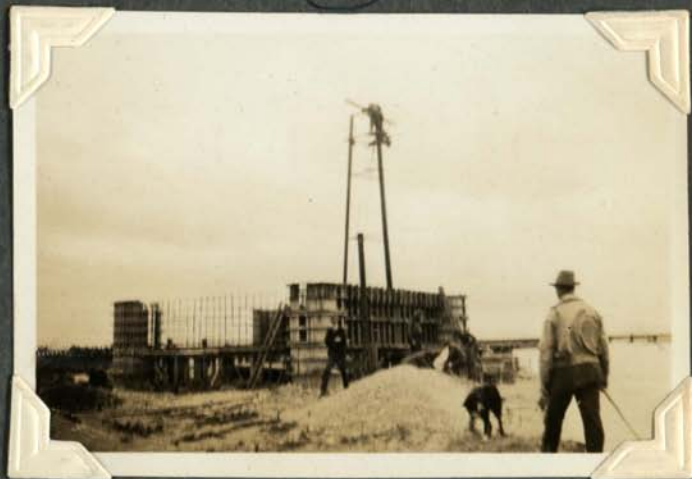
(81)

Boulder net protection in front of foundations completed. River running about 50,000 cusecs.

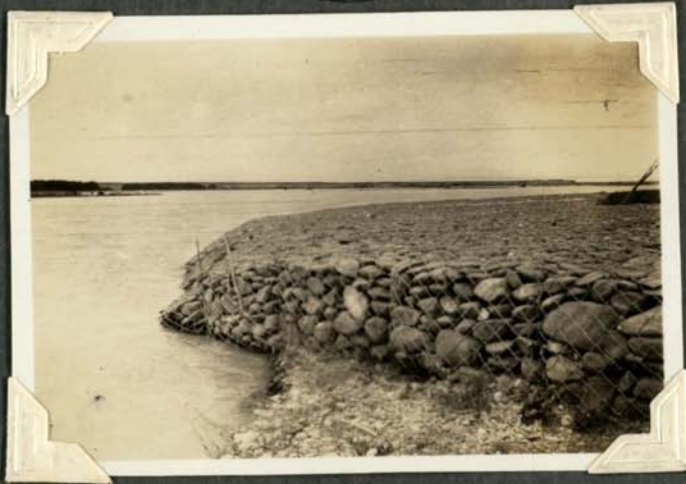
(84)

Edge of boulder nets
under scoured and dipping
to protect face of bank.

Nets 18 Ft. long arranged
in two rows & hinged to
tilt with bank scour.

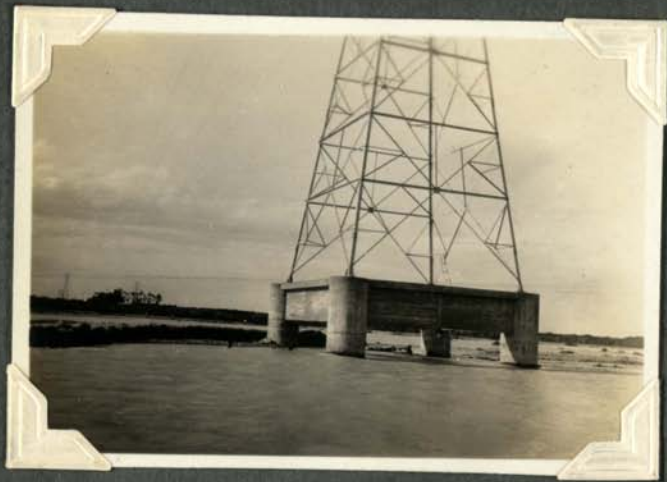
(113)

Boxing stripped from
cylinder foundations.
Cylinders 5'-6" dia. 28'-5" centres.
35 Ft. in riverbed. 44 ft overall height.

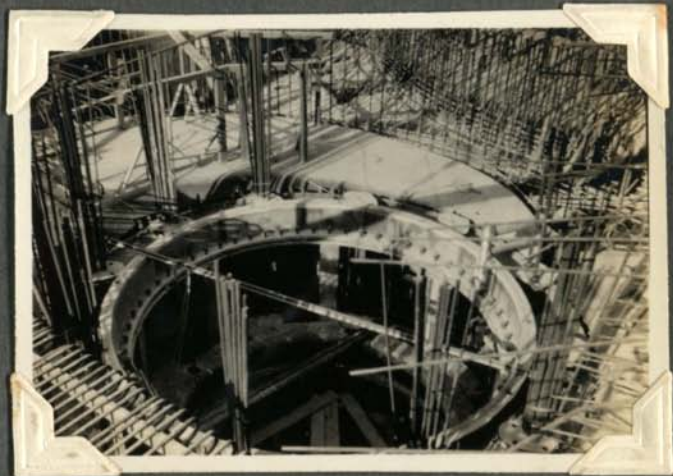
(140)

No. 1 Turbine scroll
and foundation
rings.

Bottom turbine ring
levelled ready for
checking.

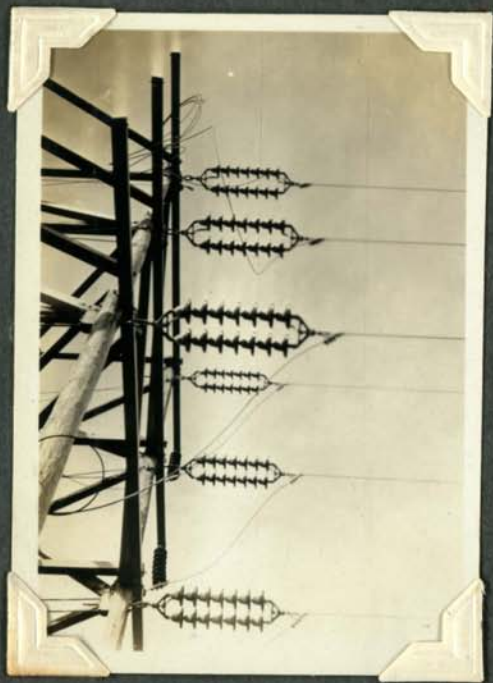
(141)

Strain structure - Glenavy.
OB. Double strain insulators
Nº 26240. East line alive
at 66,000 V.

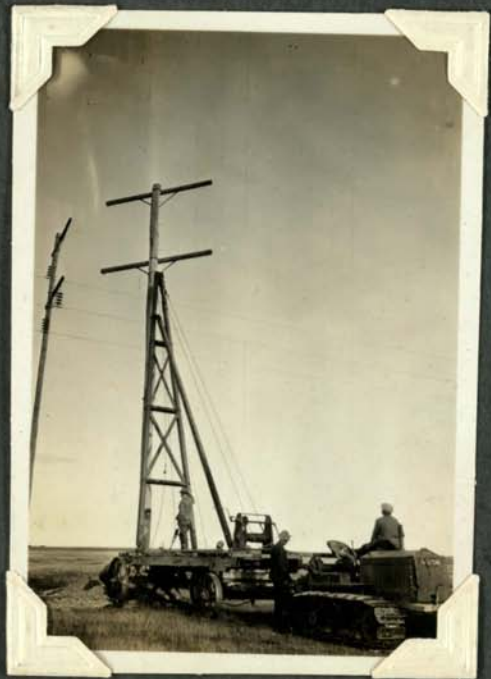
(142)

Cletrac tractor and portable
crane lifting 52 Ft. pole

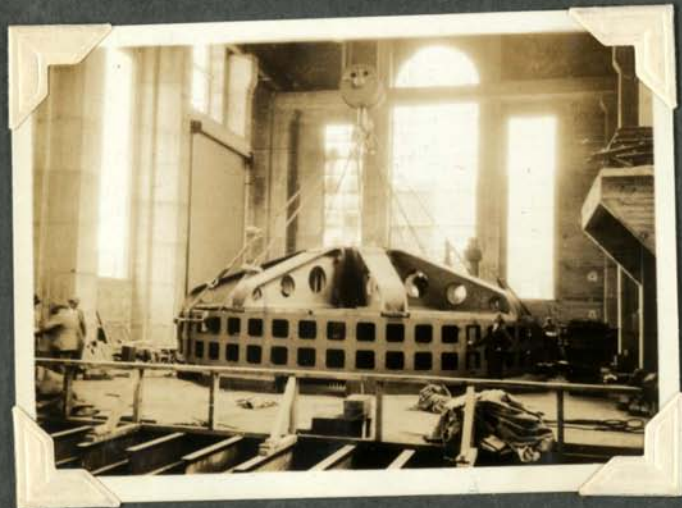
169

Stator slung ready for lifting
into position by crane.

Weight. 86 Tons.

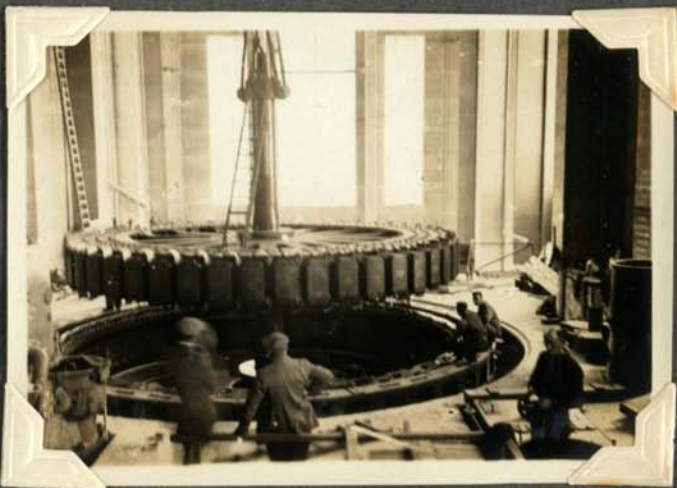
172

N^o 1 Generator rotor.

Rotor being lowered
into position.
Weight: 115 tons.
