June 3rd 1933.

Canterbury side of dam.

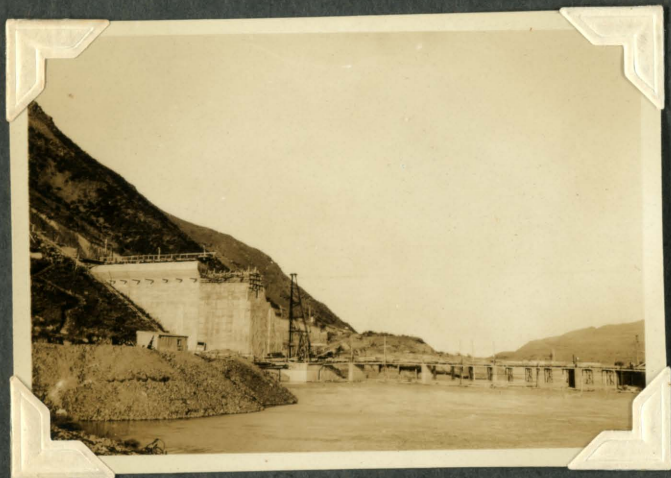
(177)

River diverted to flow
through temporary sluices.
11 Sluice gates.

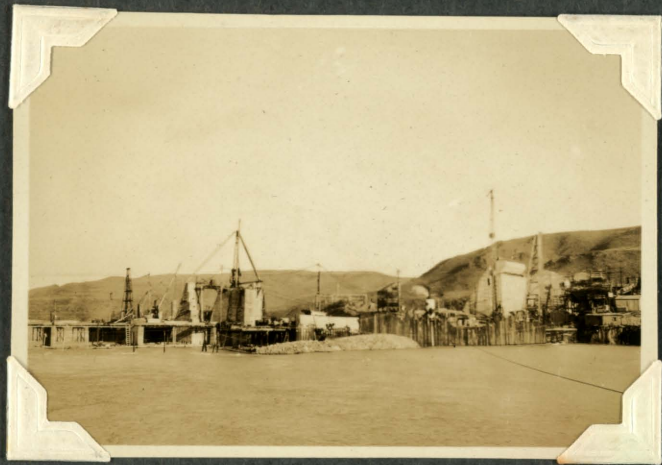
(178)

Sheet piling for final cofferdam
nearly completed across main
stream.

Otago side of dam on right.
View looking downstream.
